Case Vehicle (A): 2002 Chevrolet	Vehicle (B): 2002 Dodge
Type: Trailblazer LT, 4-door SUV 4wd	Type: Durango, 4-door SUV 4wd
Driver: 54-year-old male	Driver: 47-year-old male
CDC: 12-FLEW-3, 00-RDAO-3	CDC: 12-FDEW-4

This is a fatal crash; the driver of case vehicle (A) was fatally injured in this severe offset-frontal crash.

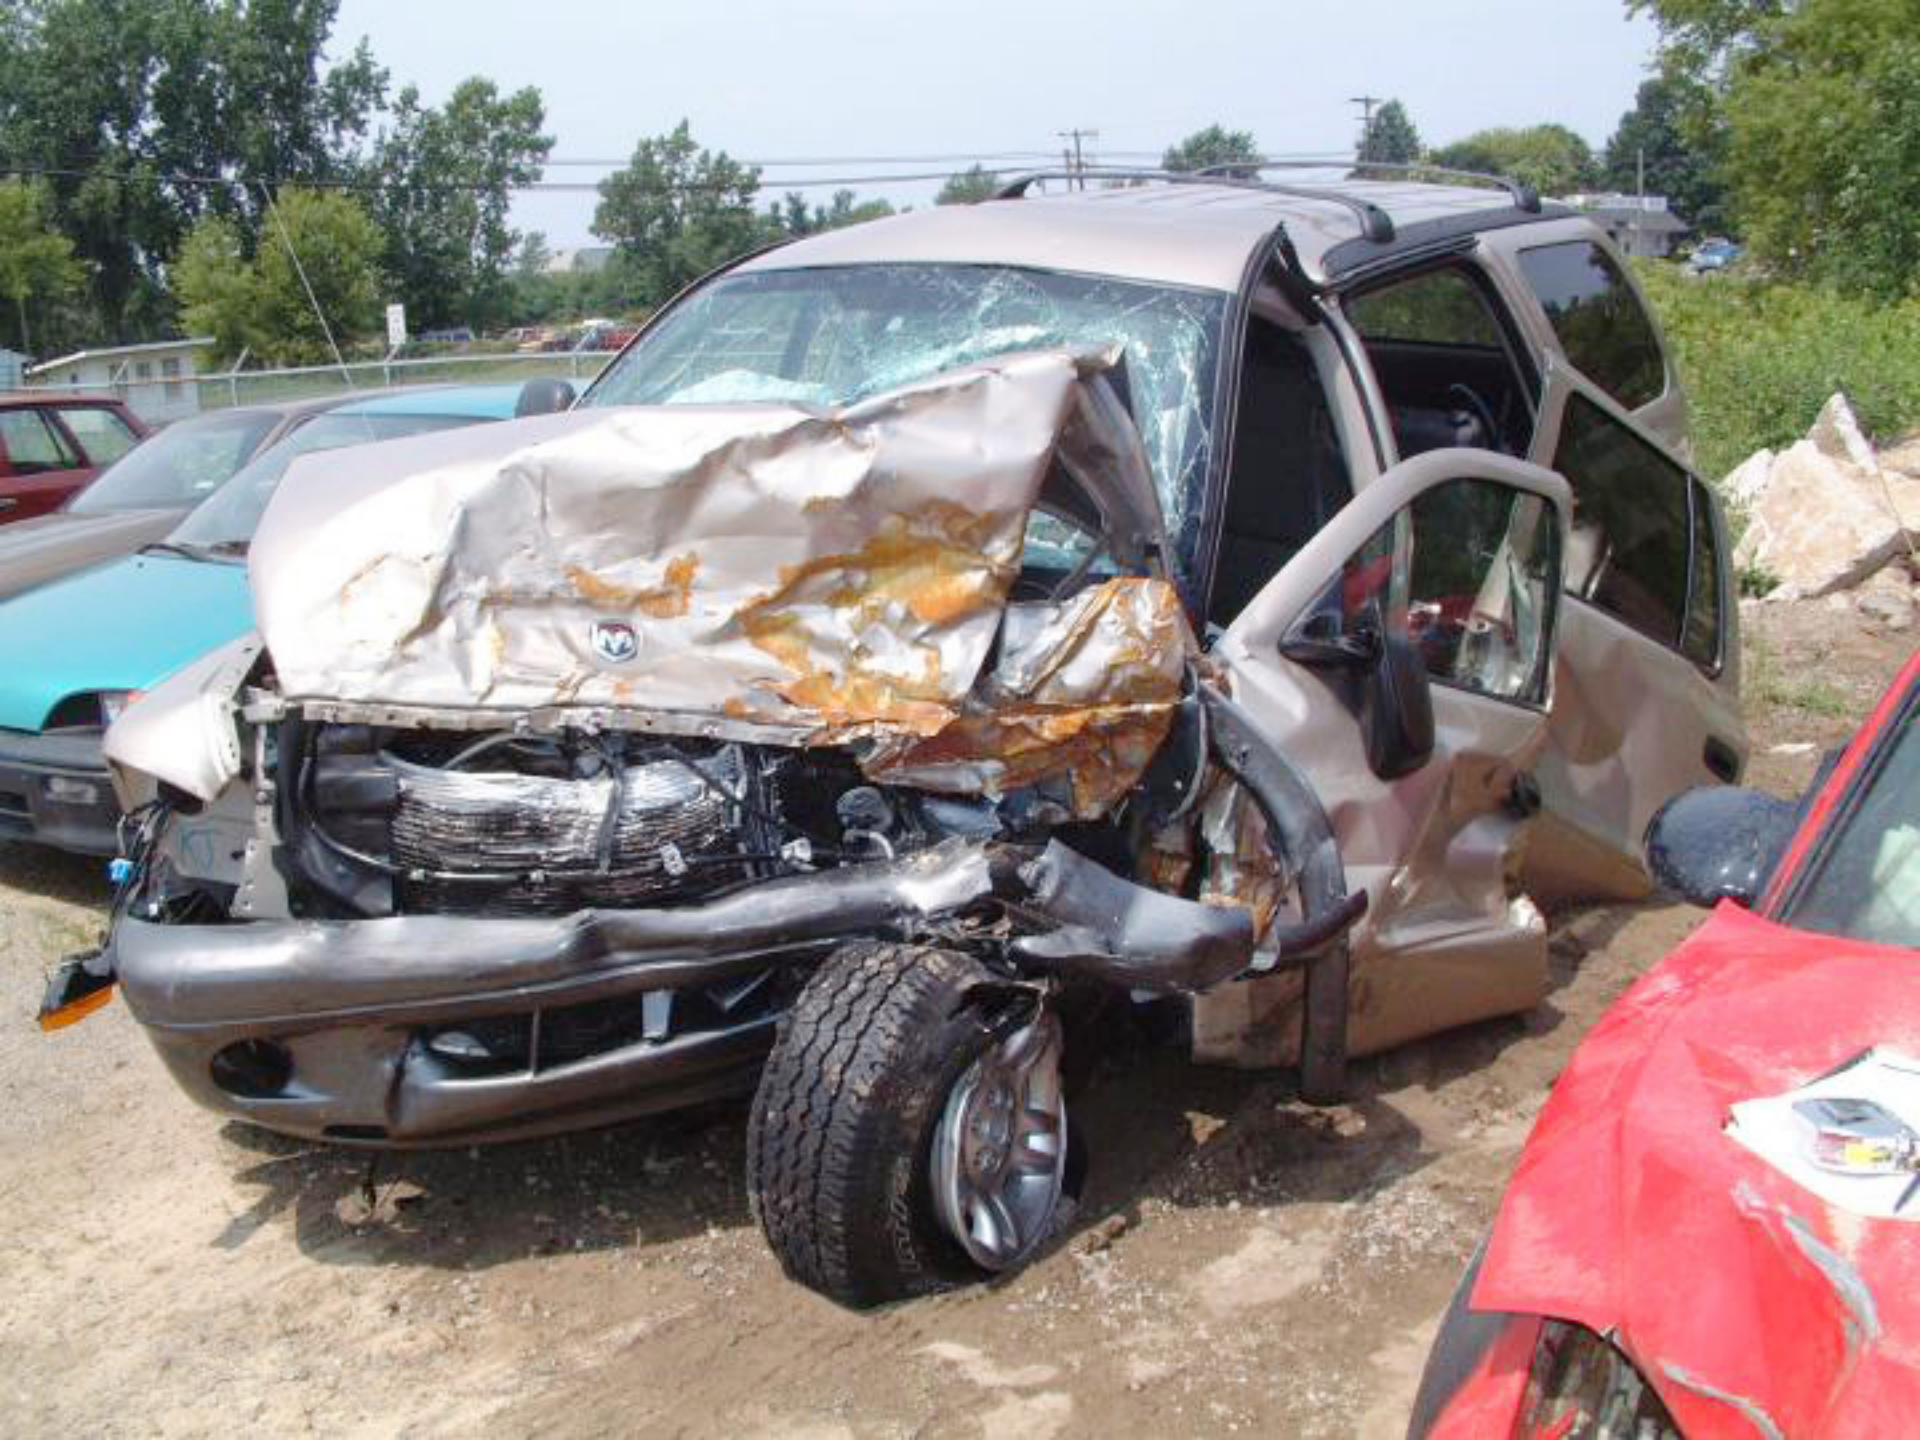
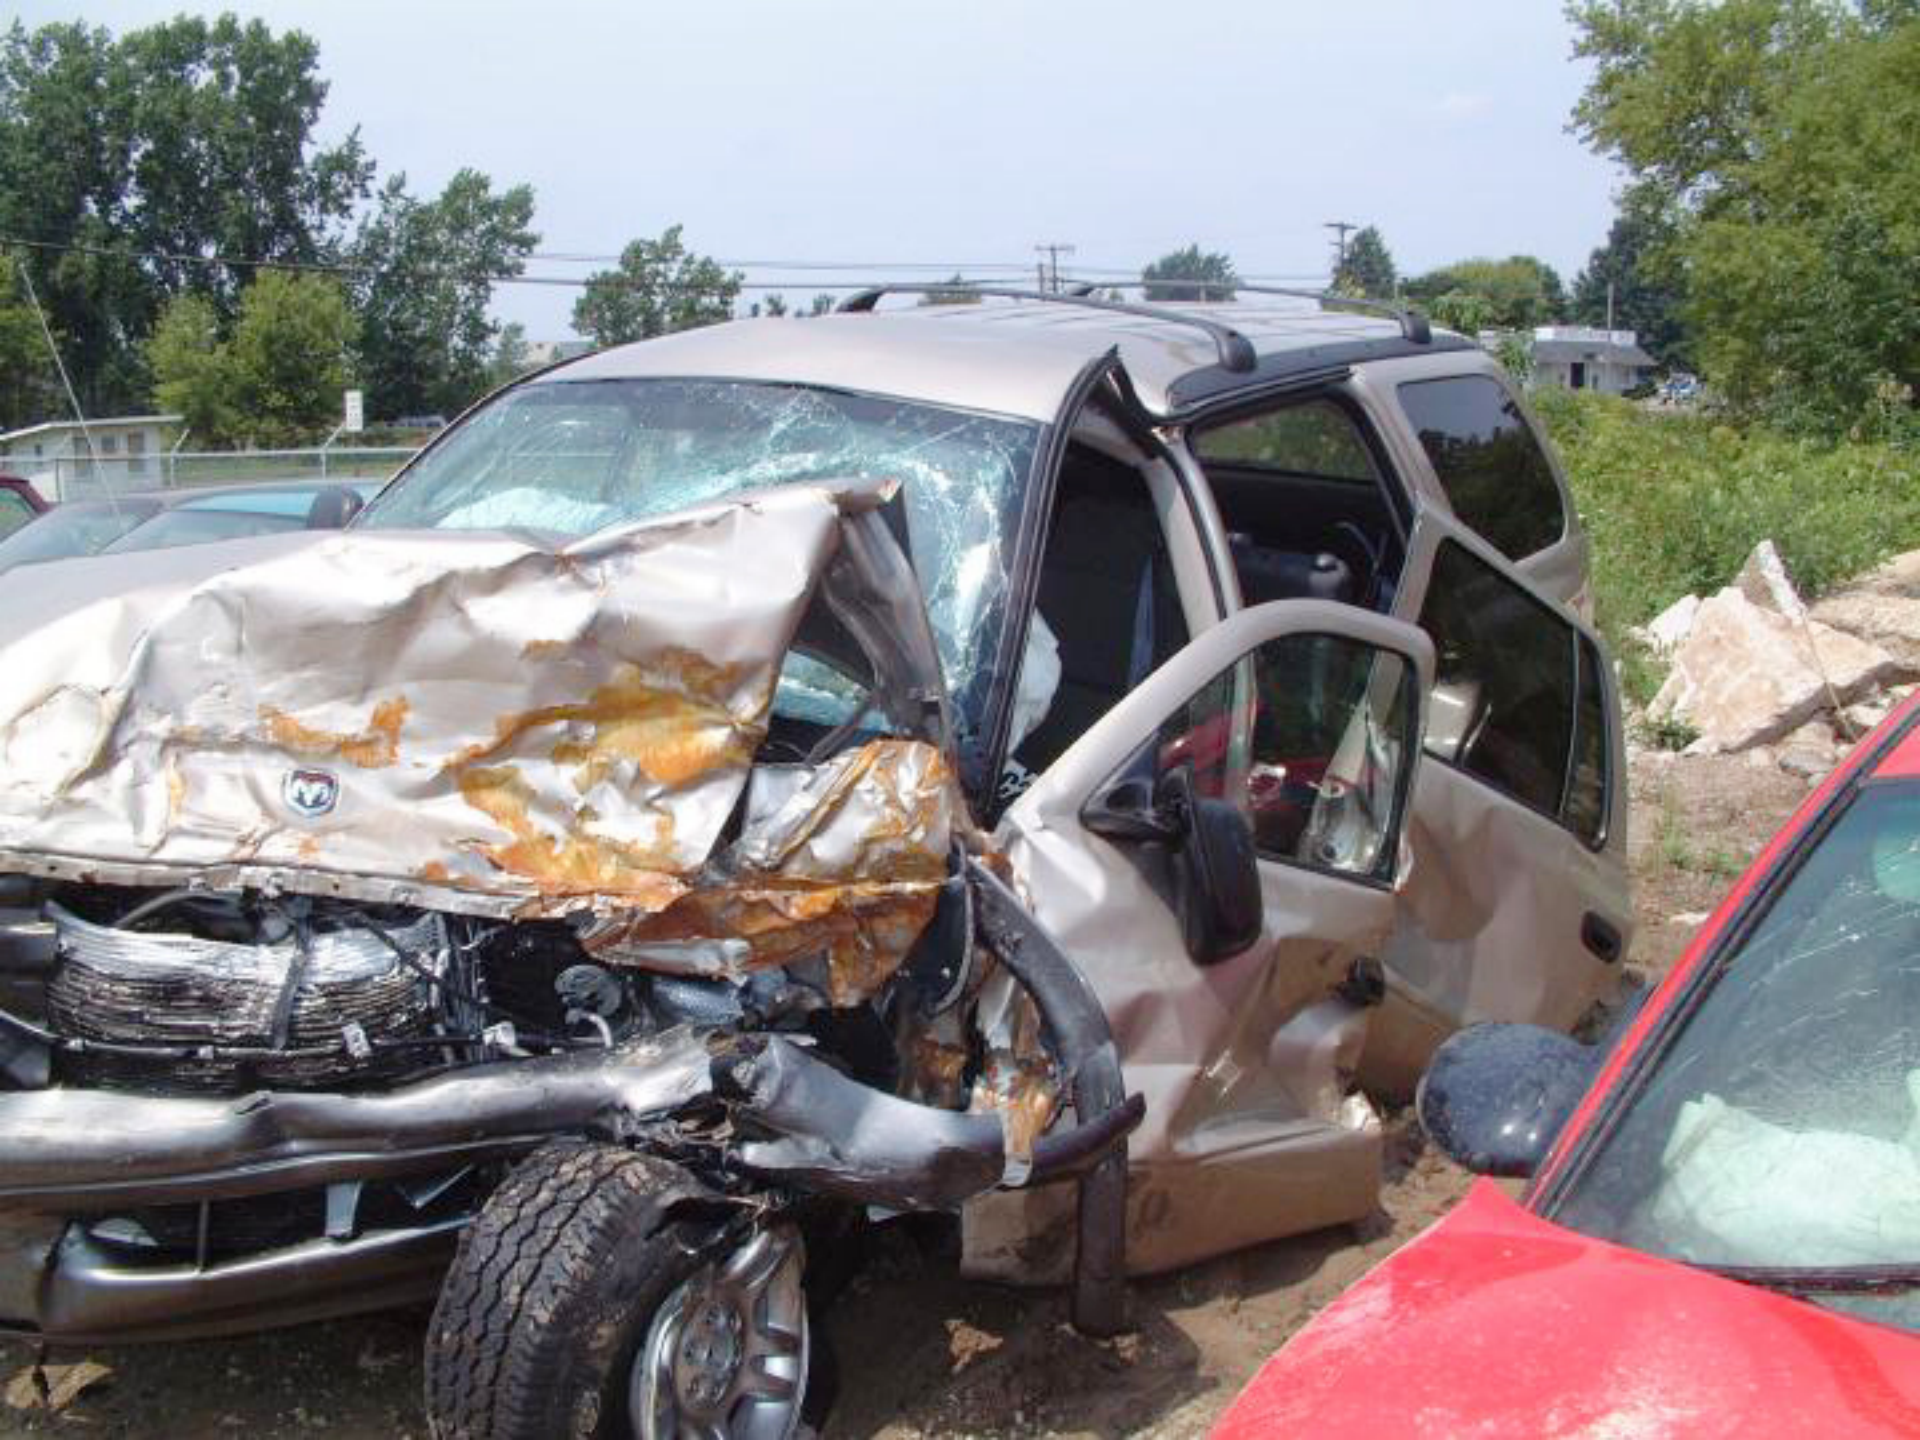
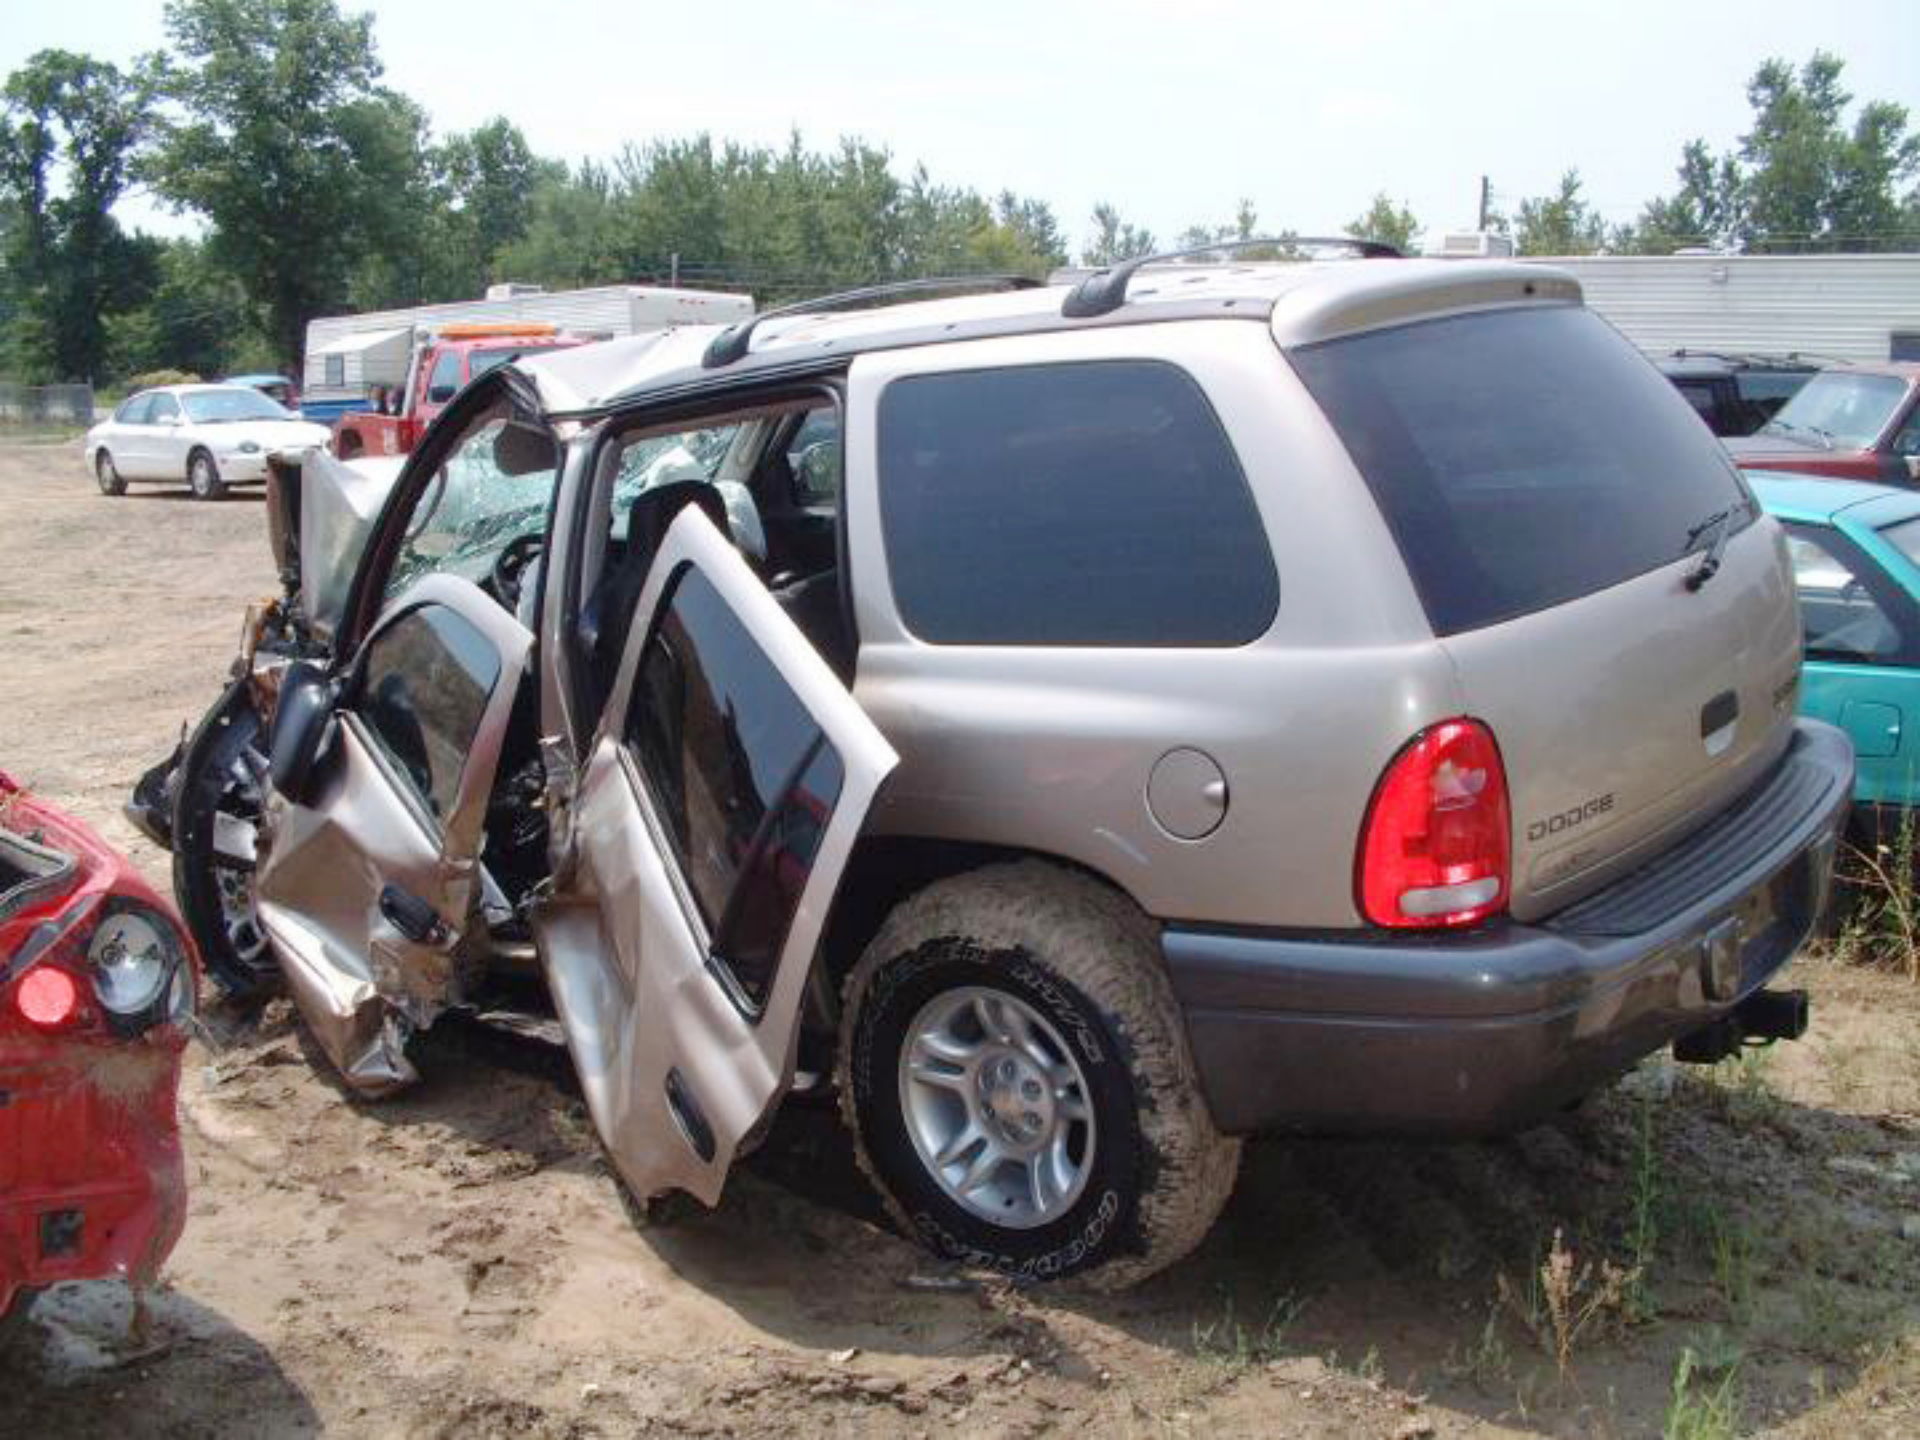
[29](#) On the left side, [30](#) the fender was separated from the vehicle, [31](#) [32](#) the left-front tire was off the rim, and the entire wheel assembly was detached from the axle. [33](#) The bottom of the upper portion of the left A-pillar was displaced rearward and the A-pillar was nearly vertical. [34](#) [35](#) Direct damage extended into the driver and left-rear doors. [36](#) Both left-side doors were jammed closed but the driver door had been removed to extricate the driver. The window frames of both left-side doors were deformed and the glazing in both doors was disintegrated. The lower portion of the left A-pillar and the upper and lower portions of the left B- and C-pillars were also damaged. [37](#) There was no damage to the left quarter panel and the window glazing above the quarter panel was not damaged. [38](#) There was no damage to the left-rear wheel and the left wheelbase could not be measured.

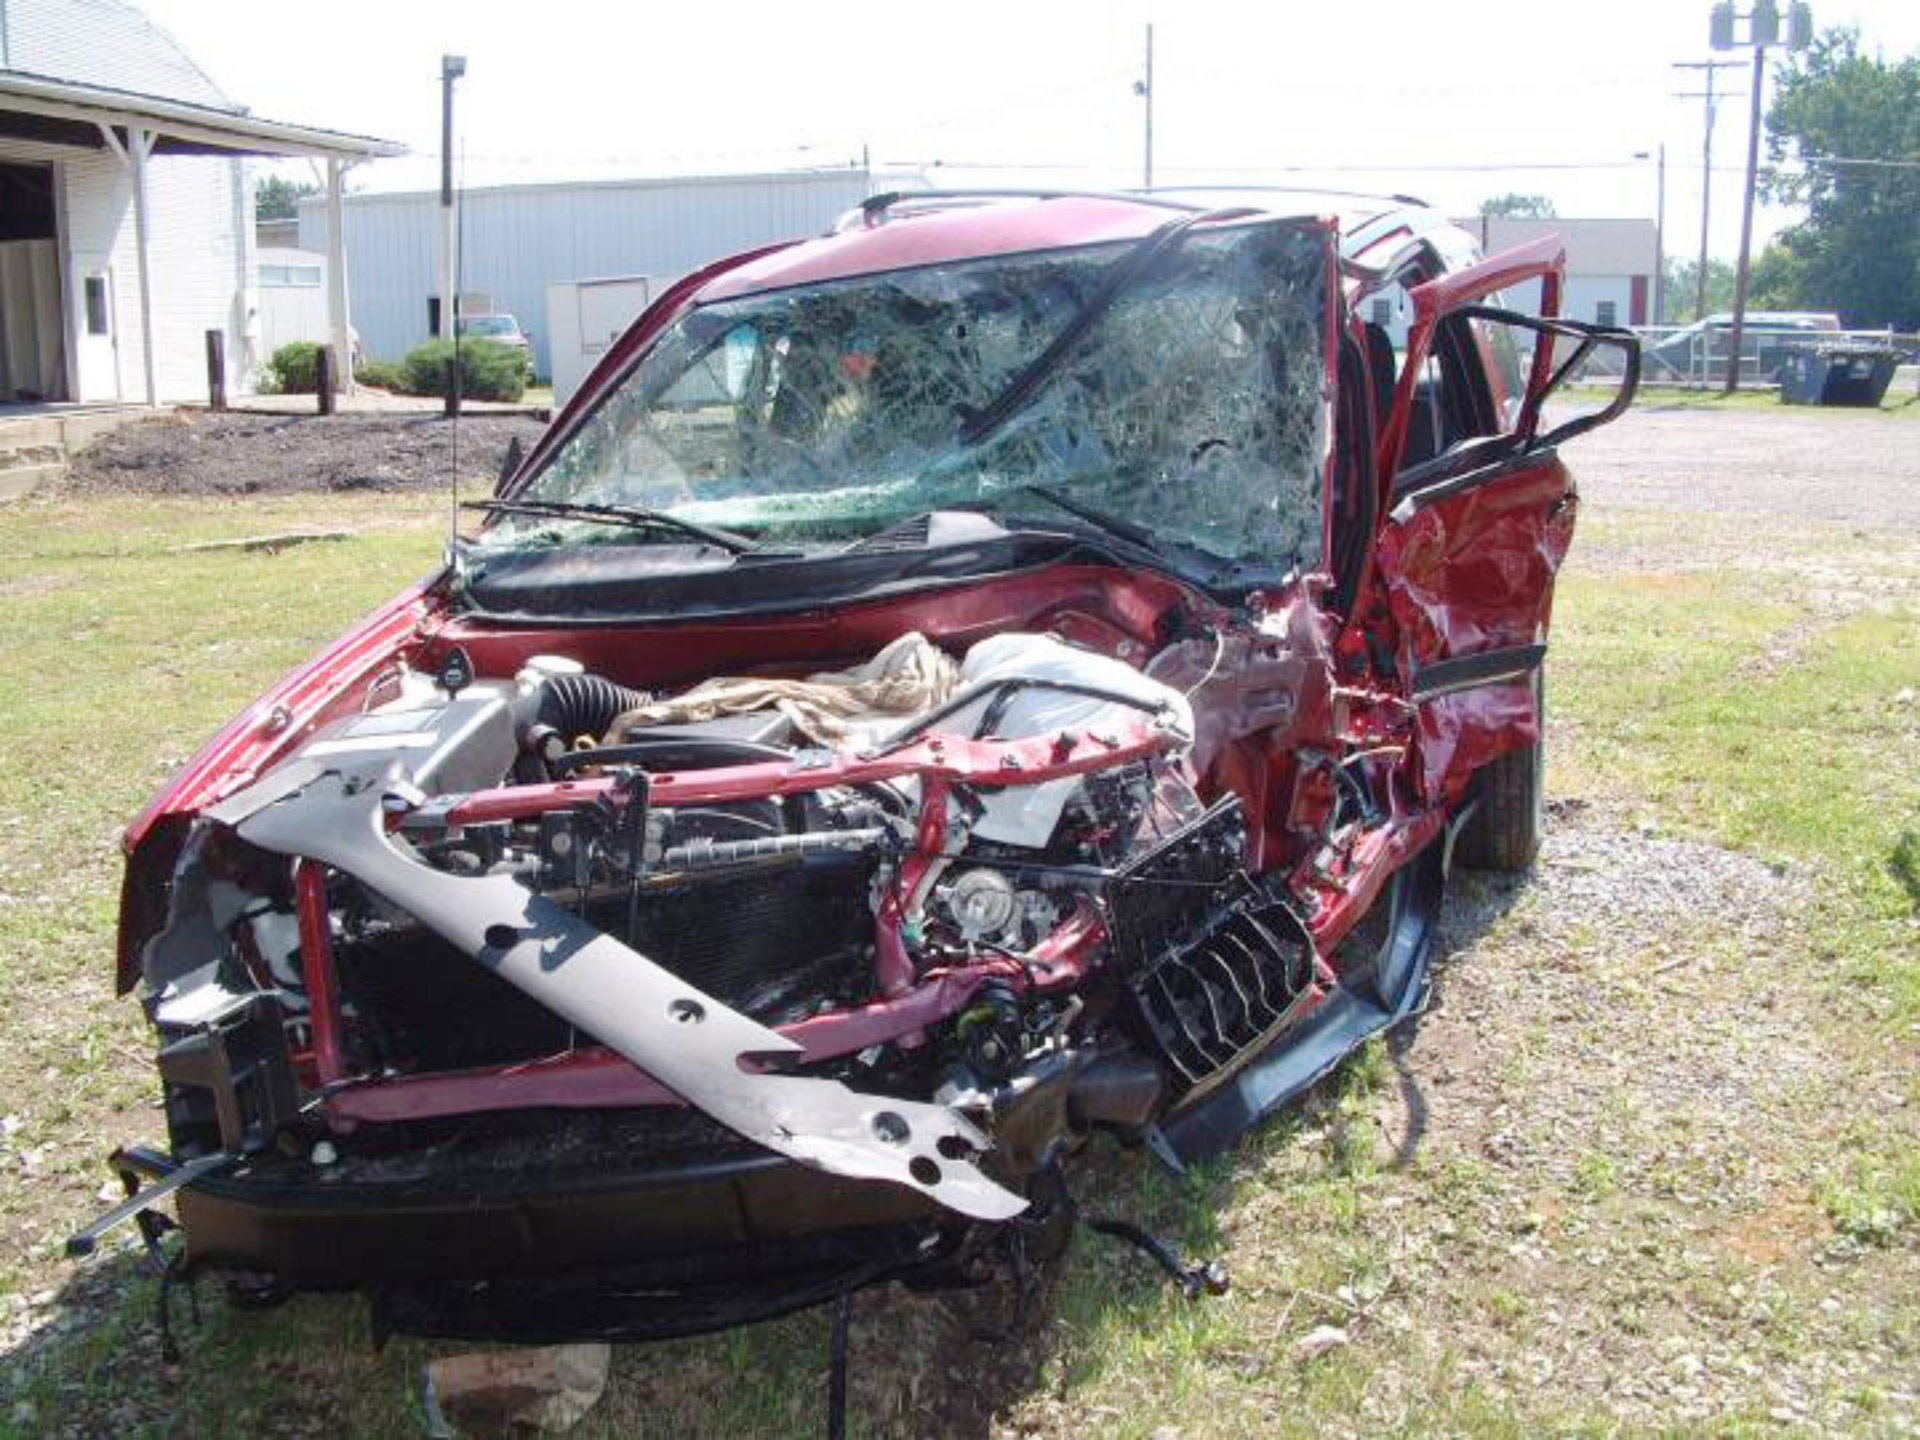
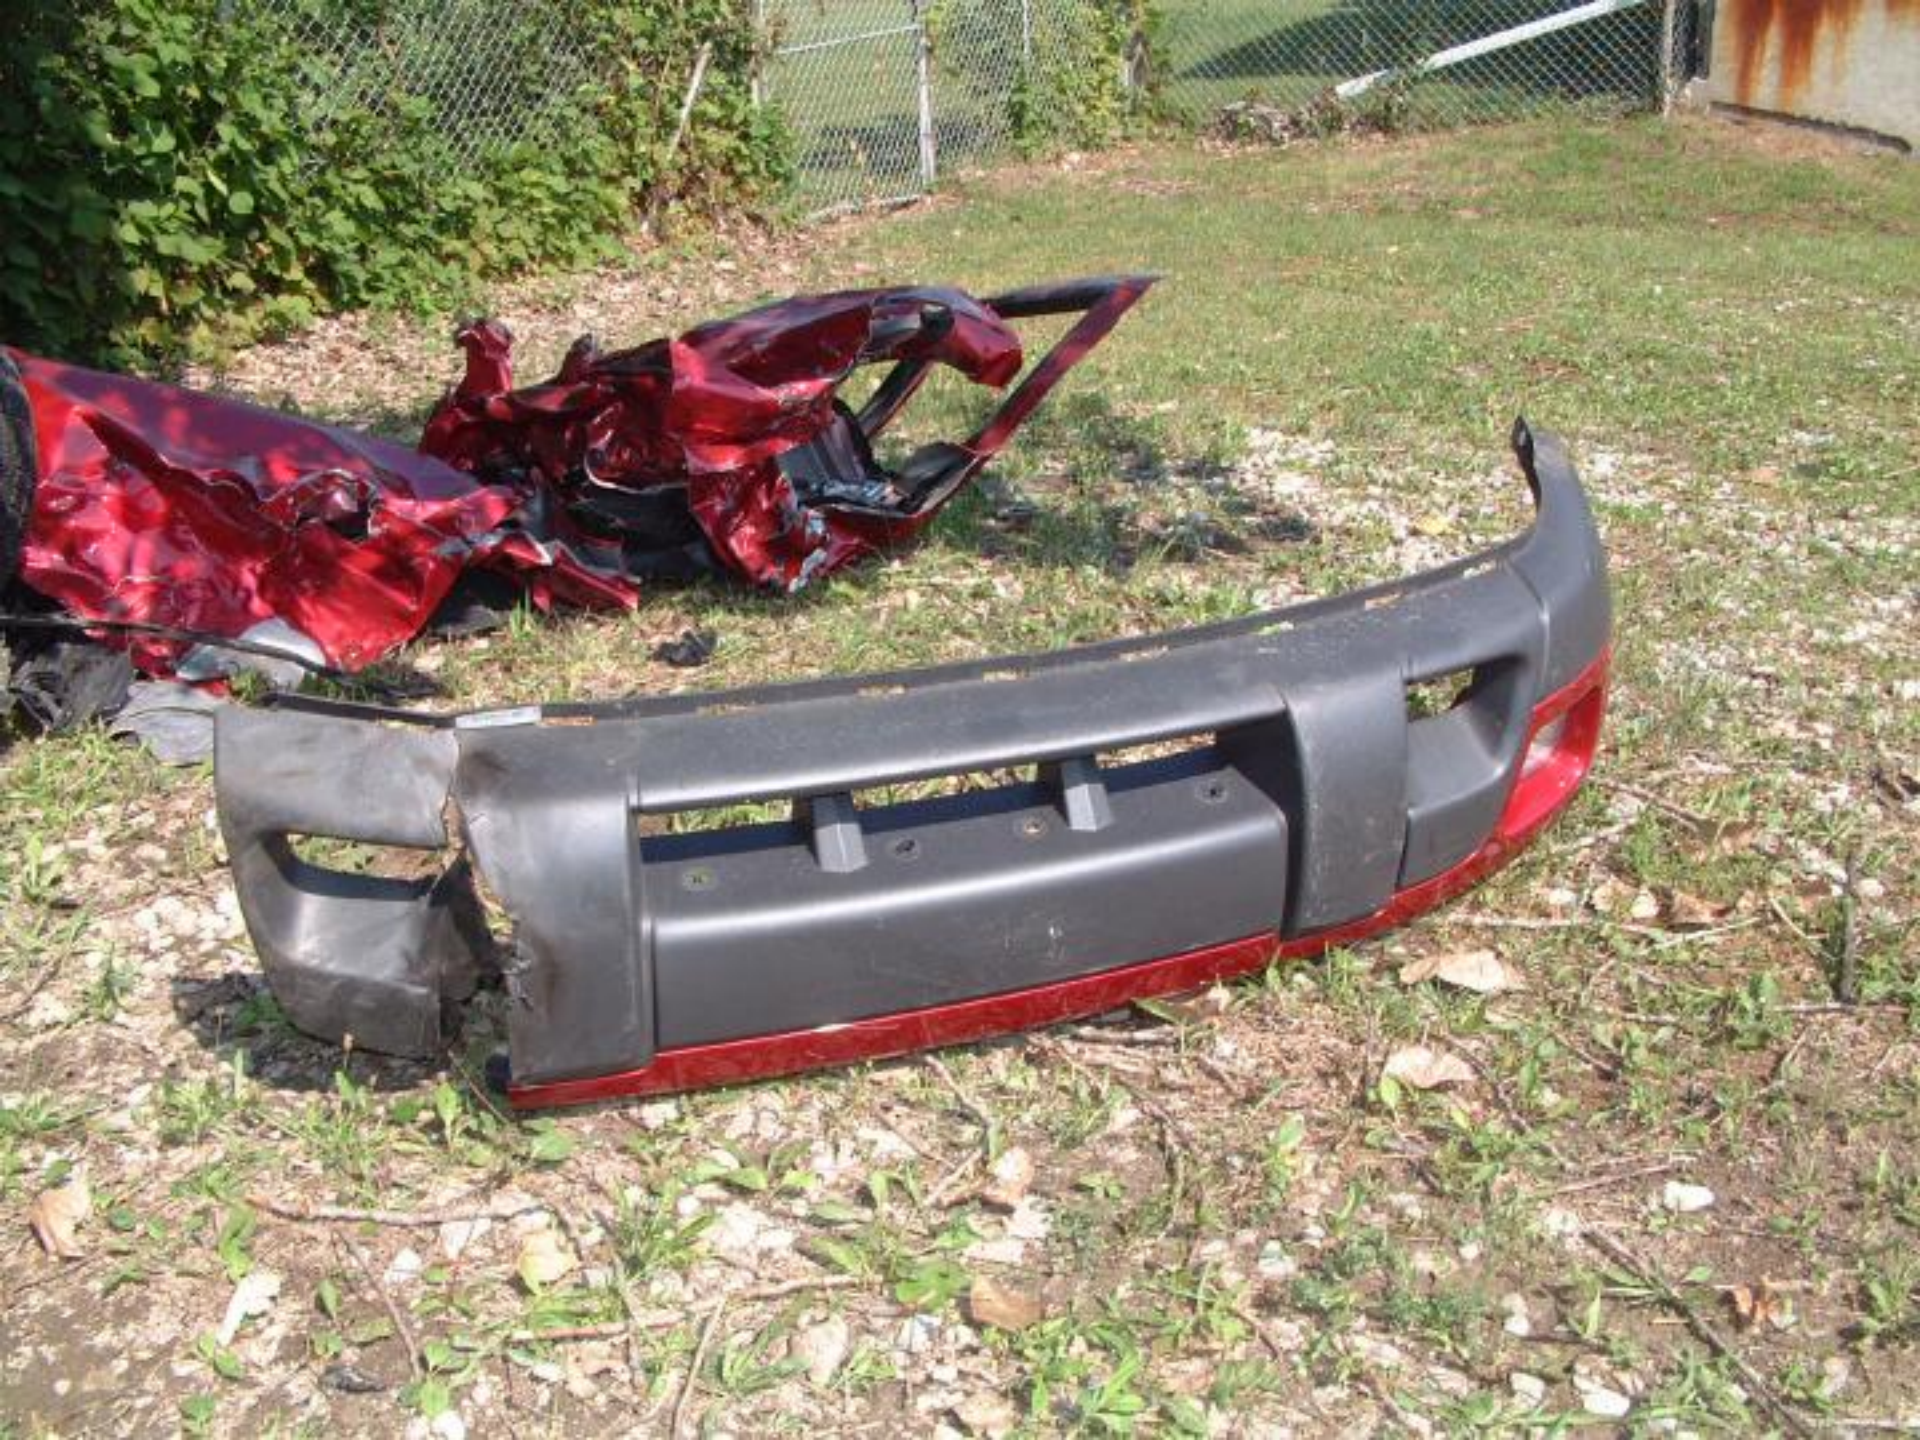
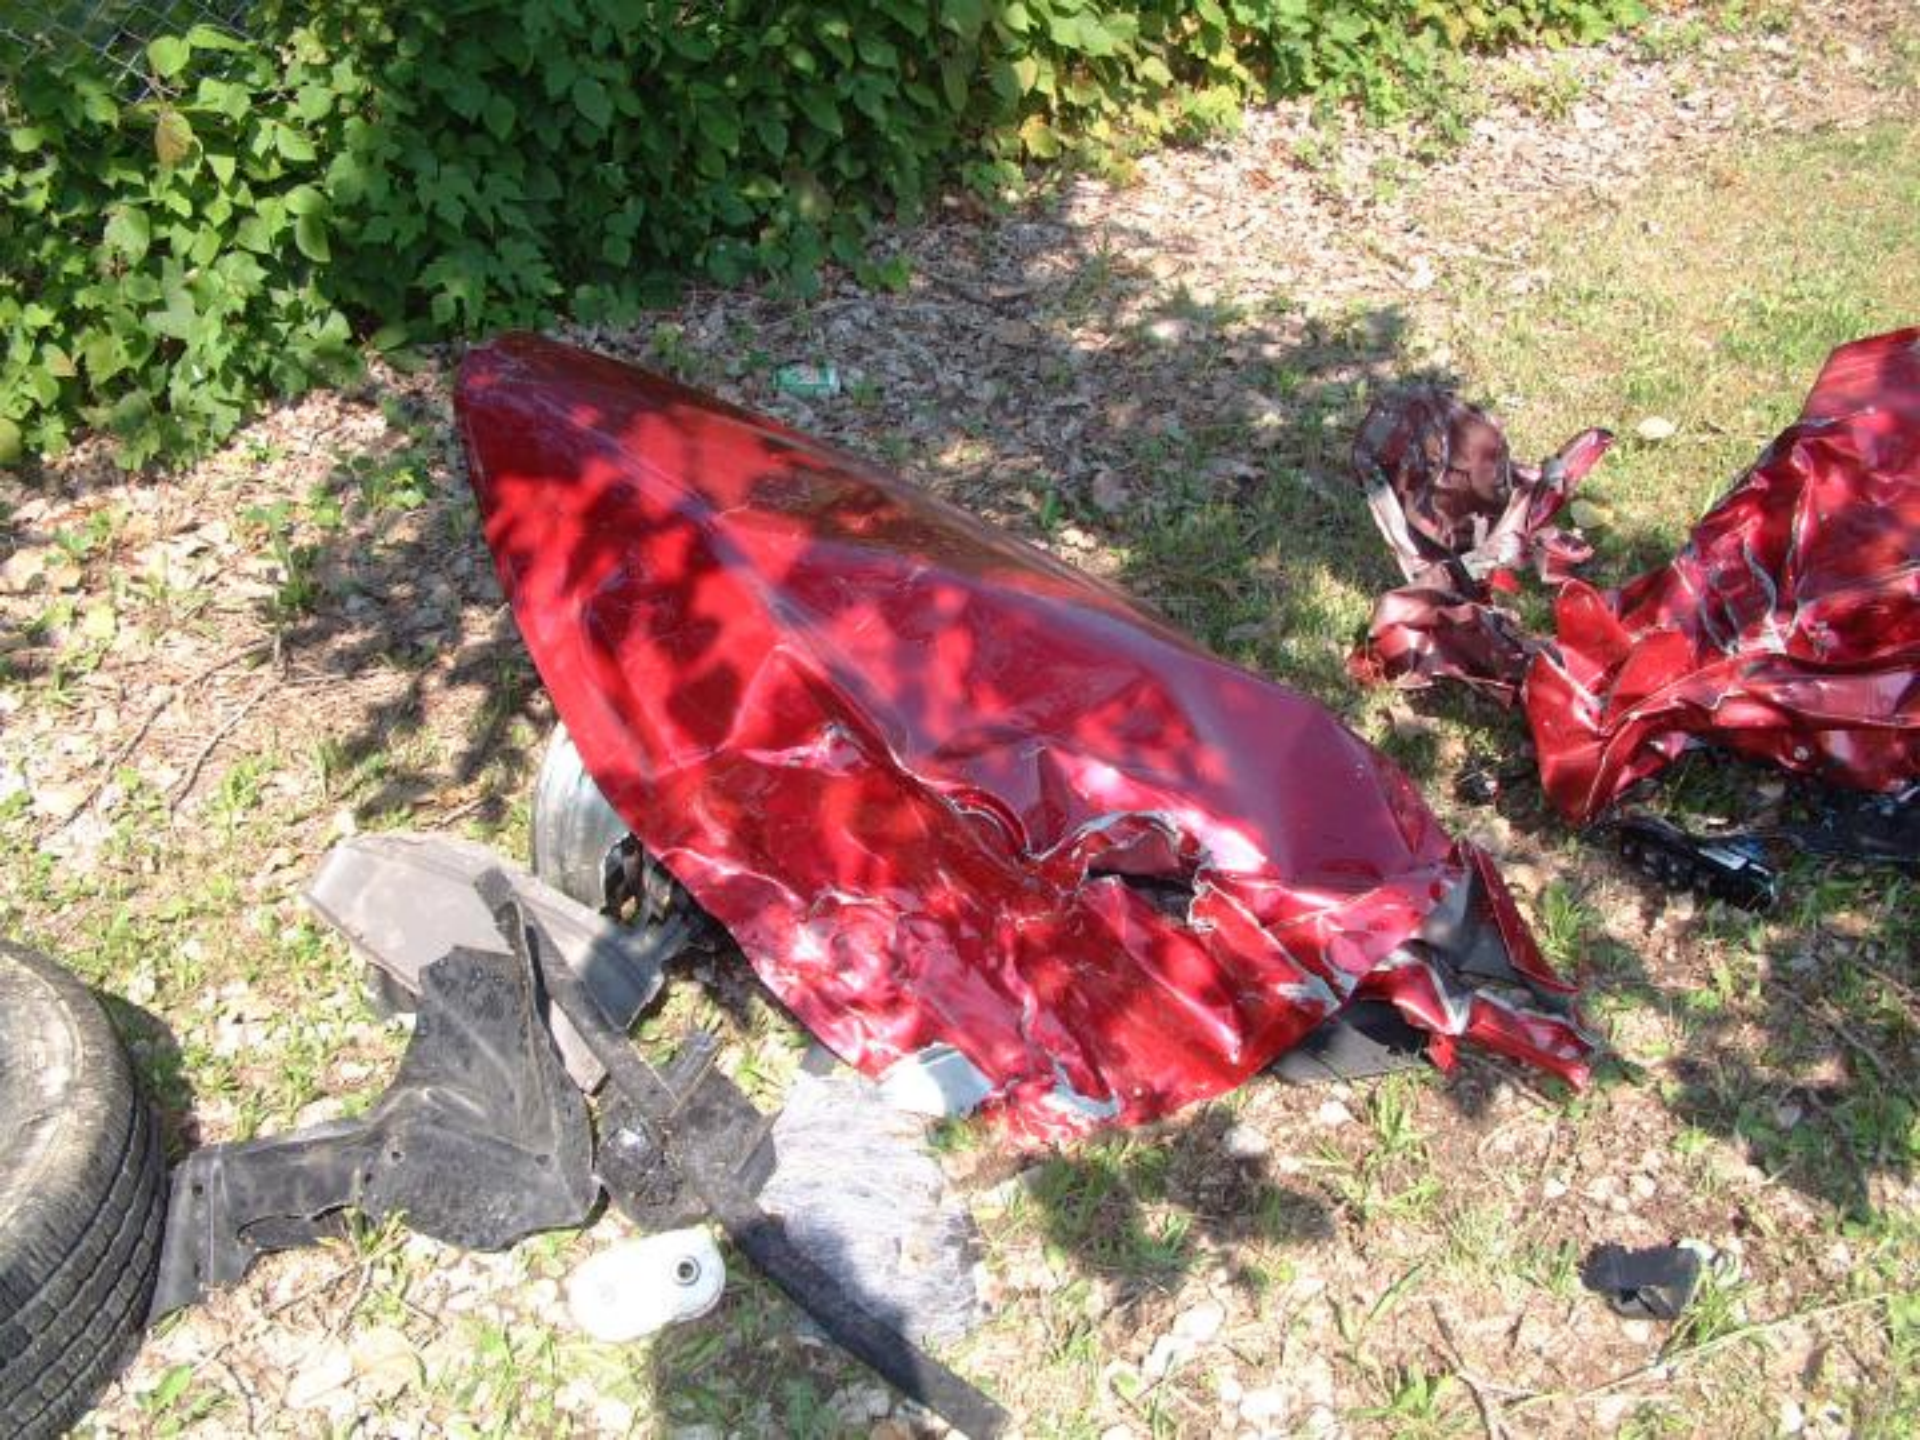
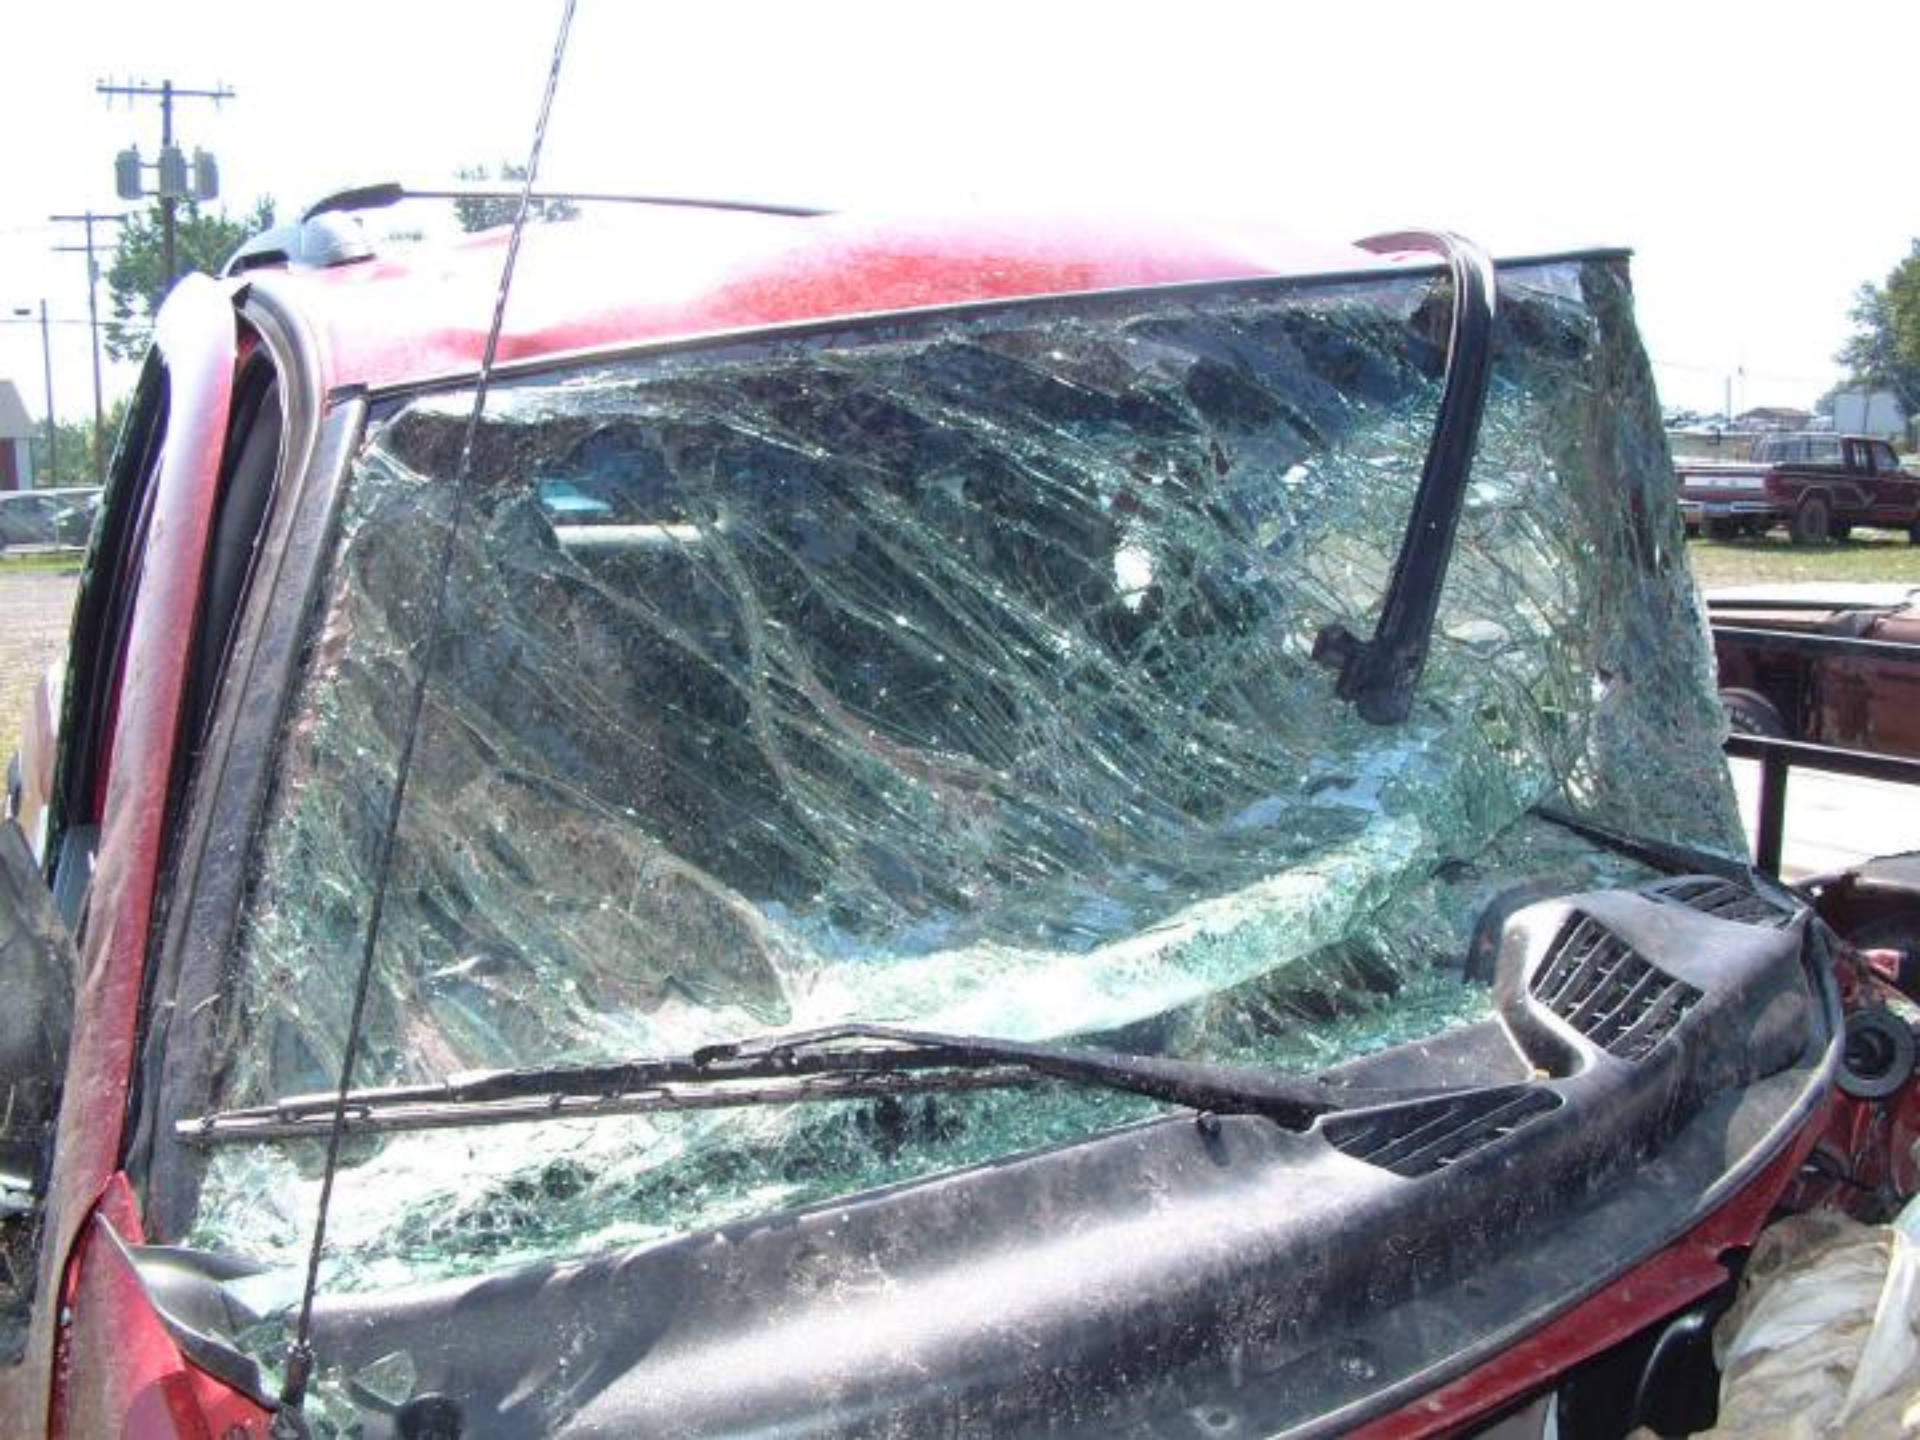
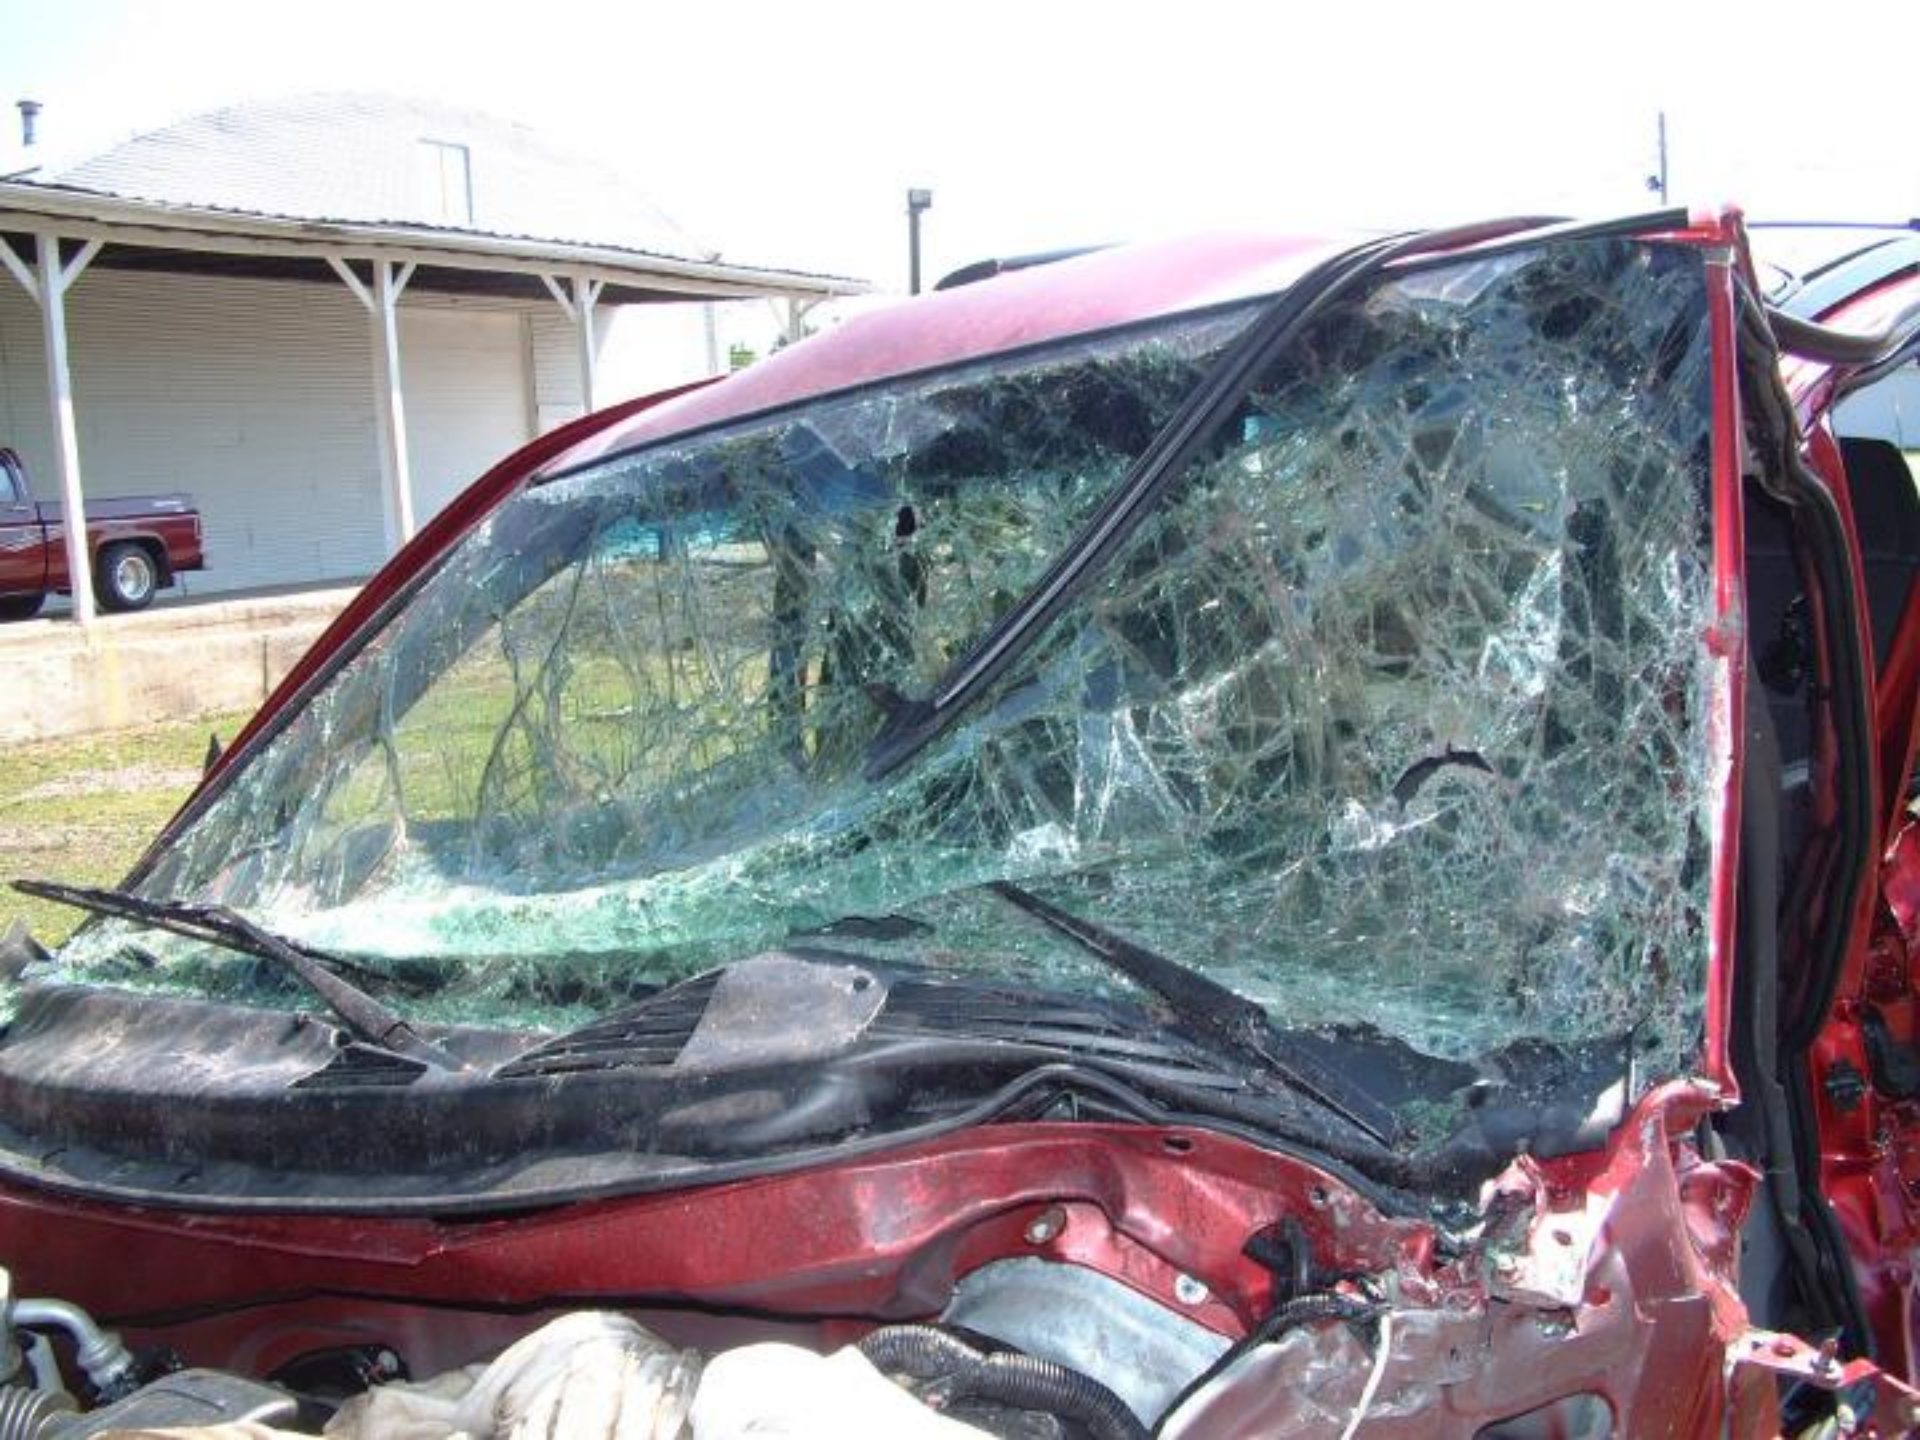
[39](#) Damage from the 1/4-turn rollover extended along the entire right side. [40](#) The right fender was deformed and deflected to the left [41](#) and both right-side doors were deformed but they were still operable. [42](#) [43](#) The door window frames were bent slightly out and all of the right-side glazing was broken except for the small window in the right-rear door. The upper portion of the A-pillar, the lower portion of the C-pillar, and the upper and lower portions of the D-pillars were all
